Manhole Inspection Summary

Manhole # S31OO1004MH

Location Address: **4501 CHARLES ST**

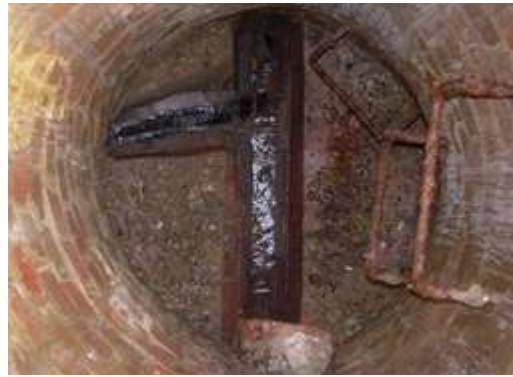
Top View

☒ **Debris** (not Condition related)

☒ **Corroded**

Corroded steps. Bench debris.

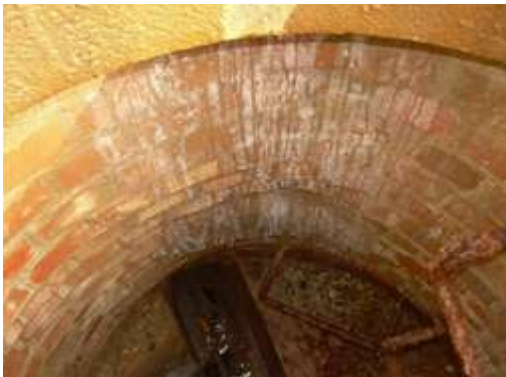
Defect

☒ **Leaks**

Infiltration: ☐ None ☒ **Joint** ☐ Cracks ☐ Mortar ☐ Roots ☐ Wall

Frame leaks. Adjustment infiltration.

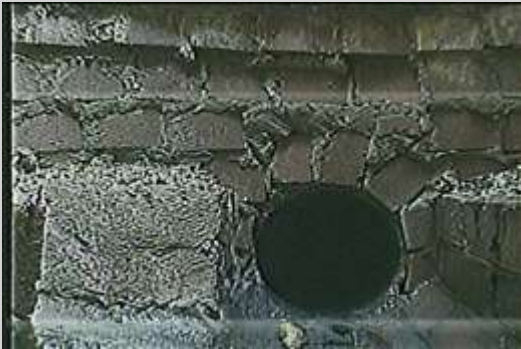
8 in. Circular Gravity Sewer Pipe Out @ 12 O'Clock

Invert Depth: **6.56** (ft.) Flow Characteristics: **Slow**

Deposits: ☒ None ☐ Mud ☐ Sludge ☐ Debris ☐ Grease

Infiltration: **None** Pipe Seal Cond: **Unknown**

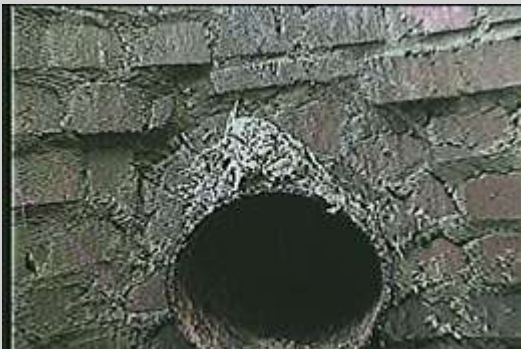
6 in. Circular Gravity Sewer Pipe In @ 6 O'Clock

Invert Depth: **3.16** (ft.) Flow Characteristics: **Slow**

Deposits: ☒ None ☐ Mud ☐ Sludge ☐ Debris ☐ Grease

Infiltration: **None** Pipe Seal Cond: **Unknown**

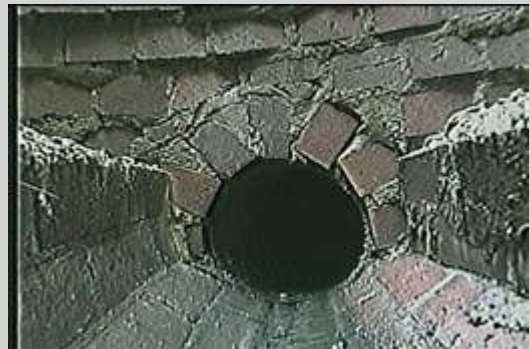
Drop In @ 6 O'Clock

Drop: **Outside** Rod and Bar

Angled: **Yes** Reading: **5.55** (ft.)

Drop Condition: **Open**

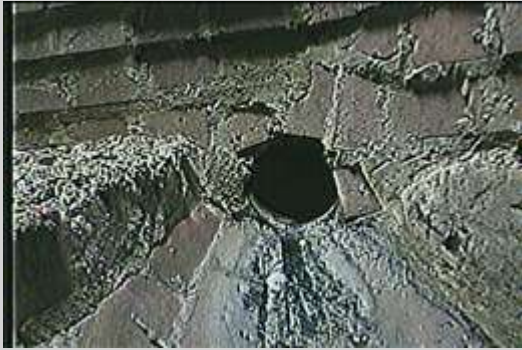
Pipe In @ 9 O'Clock

Invert Depth: **6.04** (ft.) Flow Characteristics: **None**

Deposits: ☒ None ☐ Mud ☐ Sludge ☐ Debris ☐ Grease

Infiltration: **None**
